12 Sandy Bay

Coastal Erosion Hazard Assessment

NORTHLAND REGIONAL COUNCIL
Coastal Erosion Hazard Assessment
Sandy Bay
Site: 12

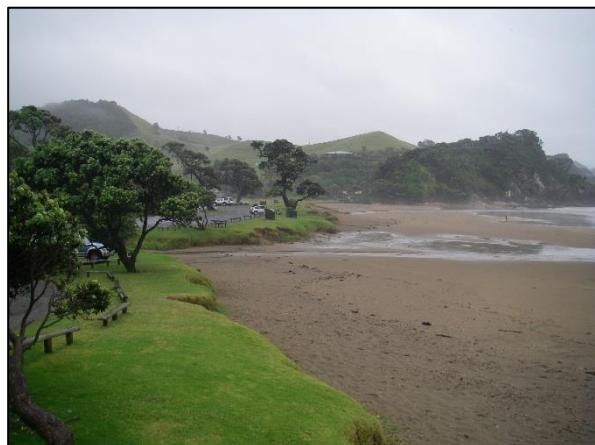
Site Photograph A (central area and stormwater outfall)

The southern 250 m of the site is a cliff shoreline which comprises Greywacke material (cell 12D). The central 150 m of the site is an eroding shoreline with a minimal dune system. The backshore elevation ranges from RL 3 to 5 m in this area (cell 12C). A stormwater outlet enters the site near the centre of the site, which has caused local retreat of the dune toe.

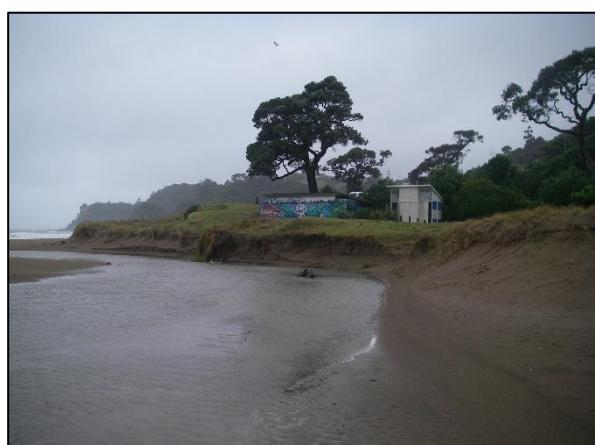
Site Photograph B (stream looking south)

Two streams enter the shoreline at the northern end of the site, with the main stream located approximately 200 m south of the northern extent of the site. The main stream flows north for approximately 100 m causing beach lowering and fluctuations in this area over time.

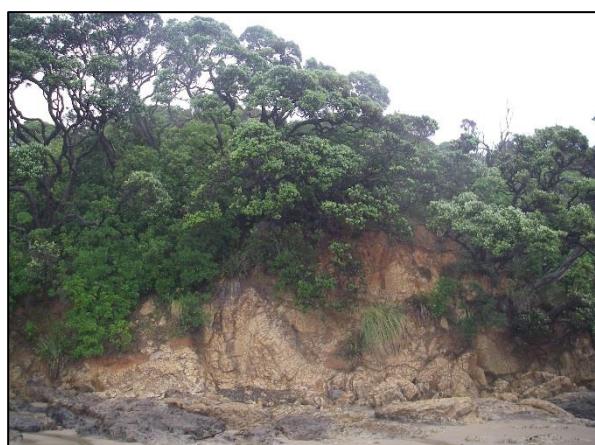
Site Photograph C (southern cliff area)

Adopted component values are presented within Table 12-1. The beaches are relatively exposed to storm waves from the E to NE and short-term erosion rates range from 15 to 25 m. Long-term shoreline trends are generally variable at the north end of the beach and erosional at the south. They Greywacke cliff at the southern end of the bay is approximately 20 m high with a stable angle of repose of between 18 and 27°.

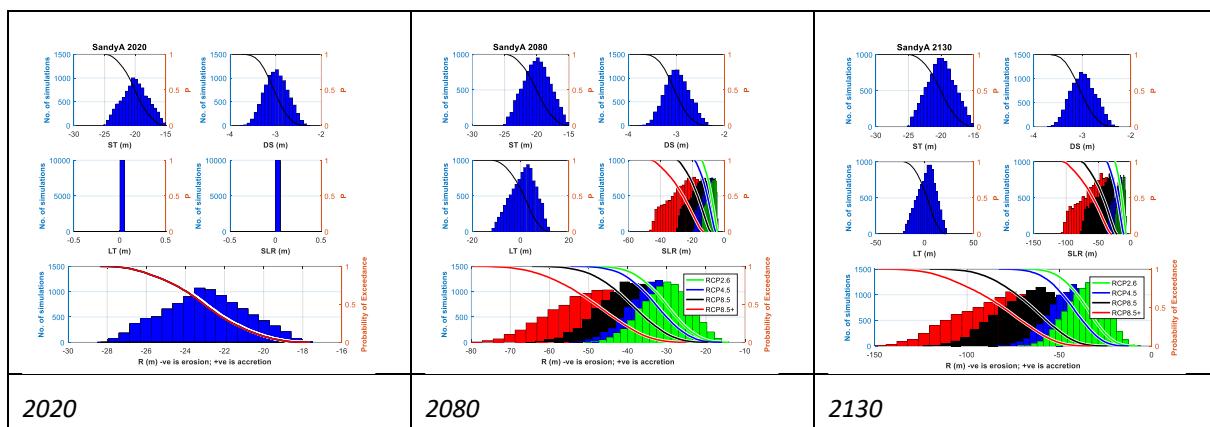
Figure 12-1 Histograms of parameter samples and the resultant shoreline distances for 2020, 2080 and 2130 timeframes for cell 12A

Histograms of individual components and resultant CEHZ distances using a Monte Carlo technique are shown in Figure 12-1 to Figure 12-5.

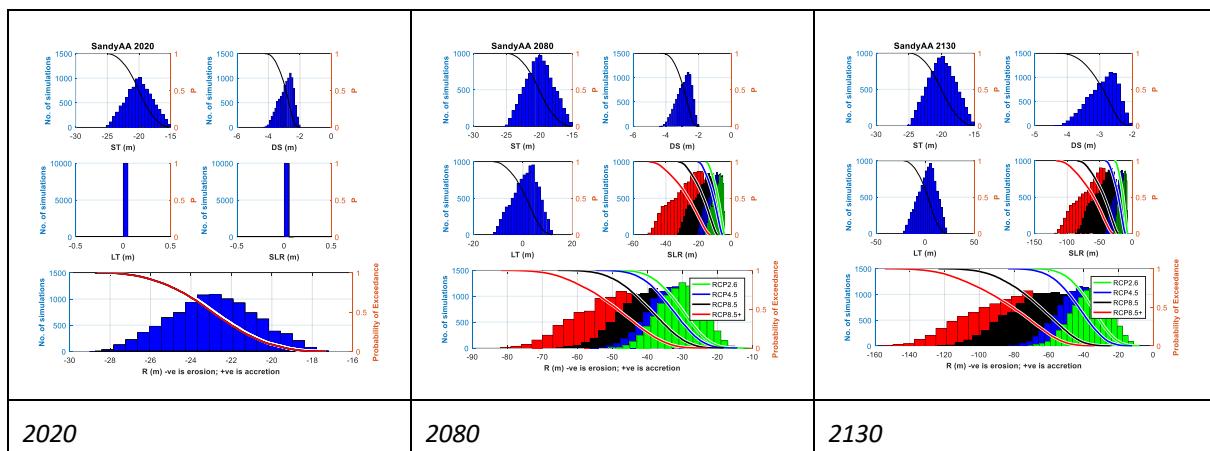
Figure 12-2 Histograms of parameter samples and the resultant shoreline distances for 2020, 2080 and 2130 timeframes for cell 12AA

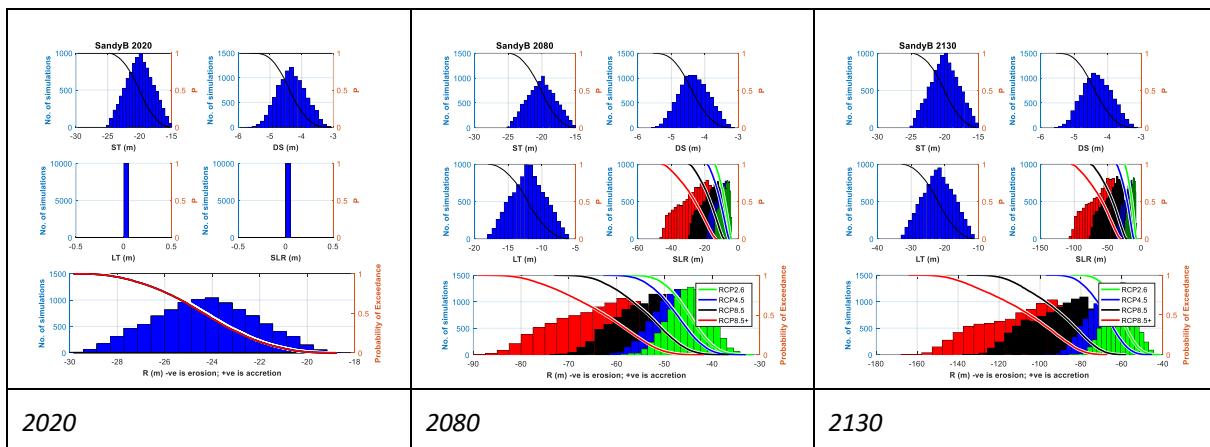
Figure 12-3 Histograms of parameter samples and the resultant shoreline distances for 2020, 2080 and 2130 timeframes for cell 12B

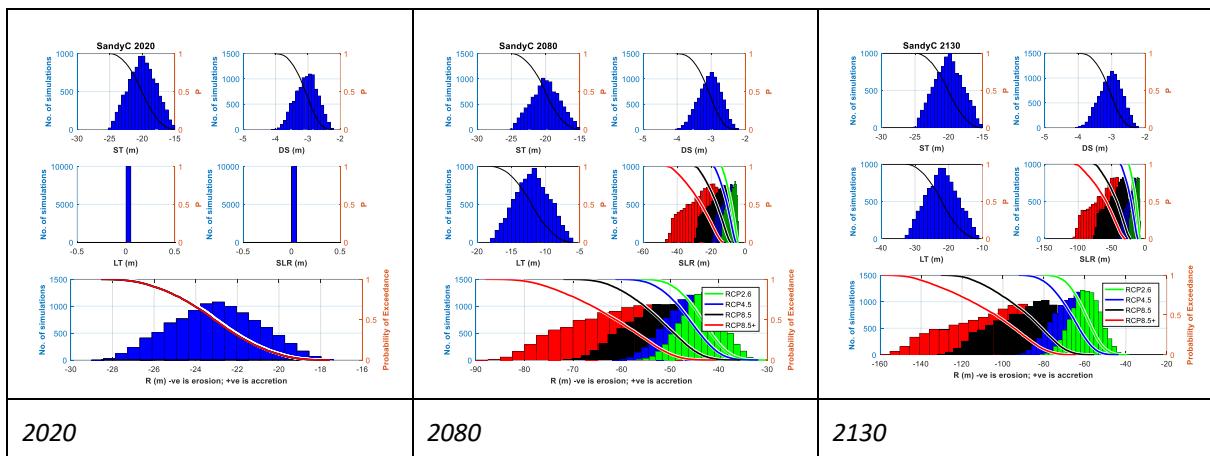
Figure 12-4 Histograms of parameter samples and the resultant shoreline distances for 2020, 2080 and 2130 timeframes for cell 12C

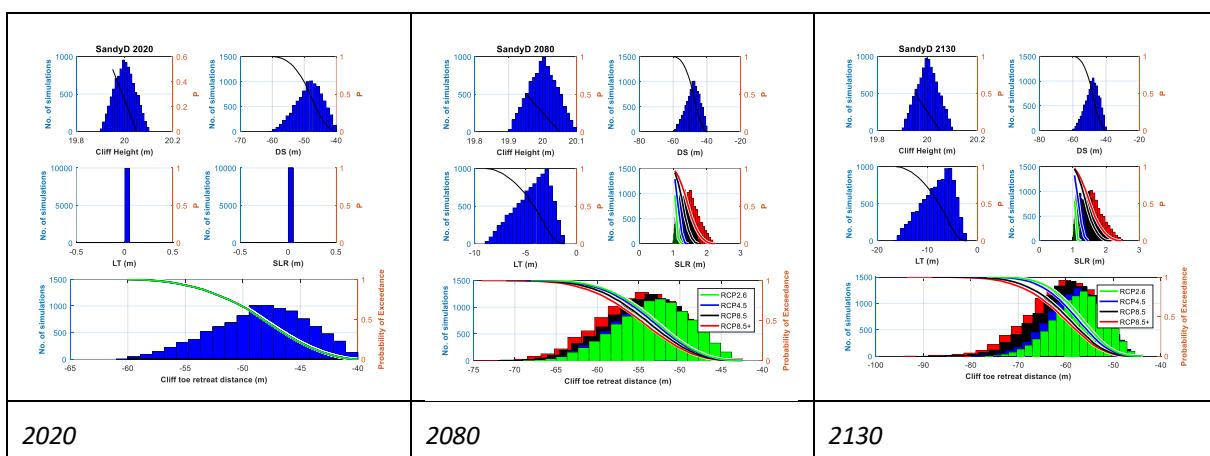
Figure 12-5 Histograms of parameter samples and the resultant shoreline distances for 2020, 2080 and 2130 timeframes for cell 12D

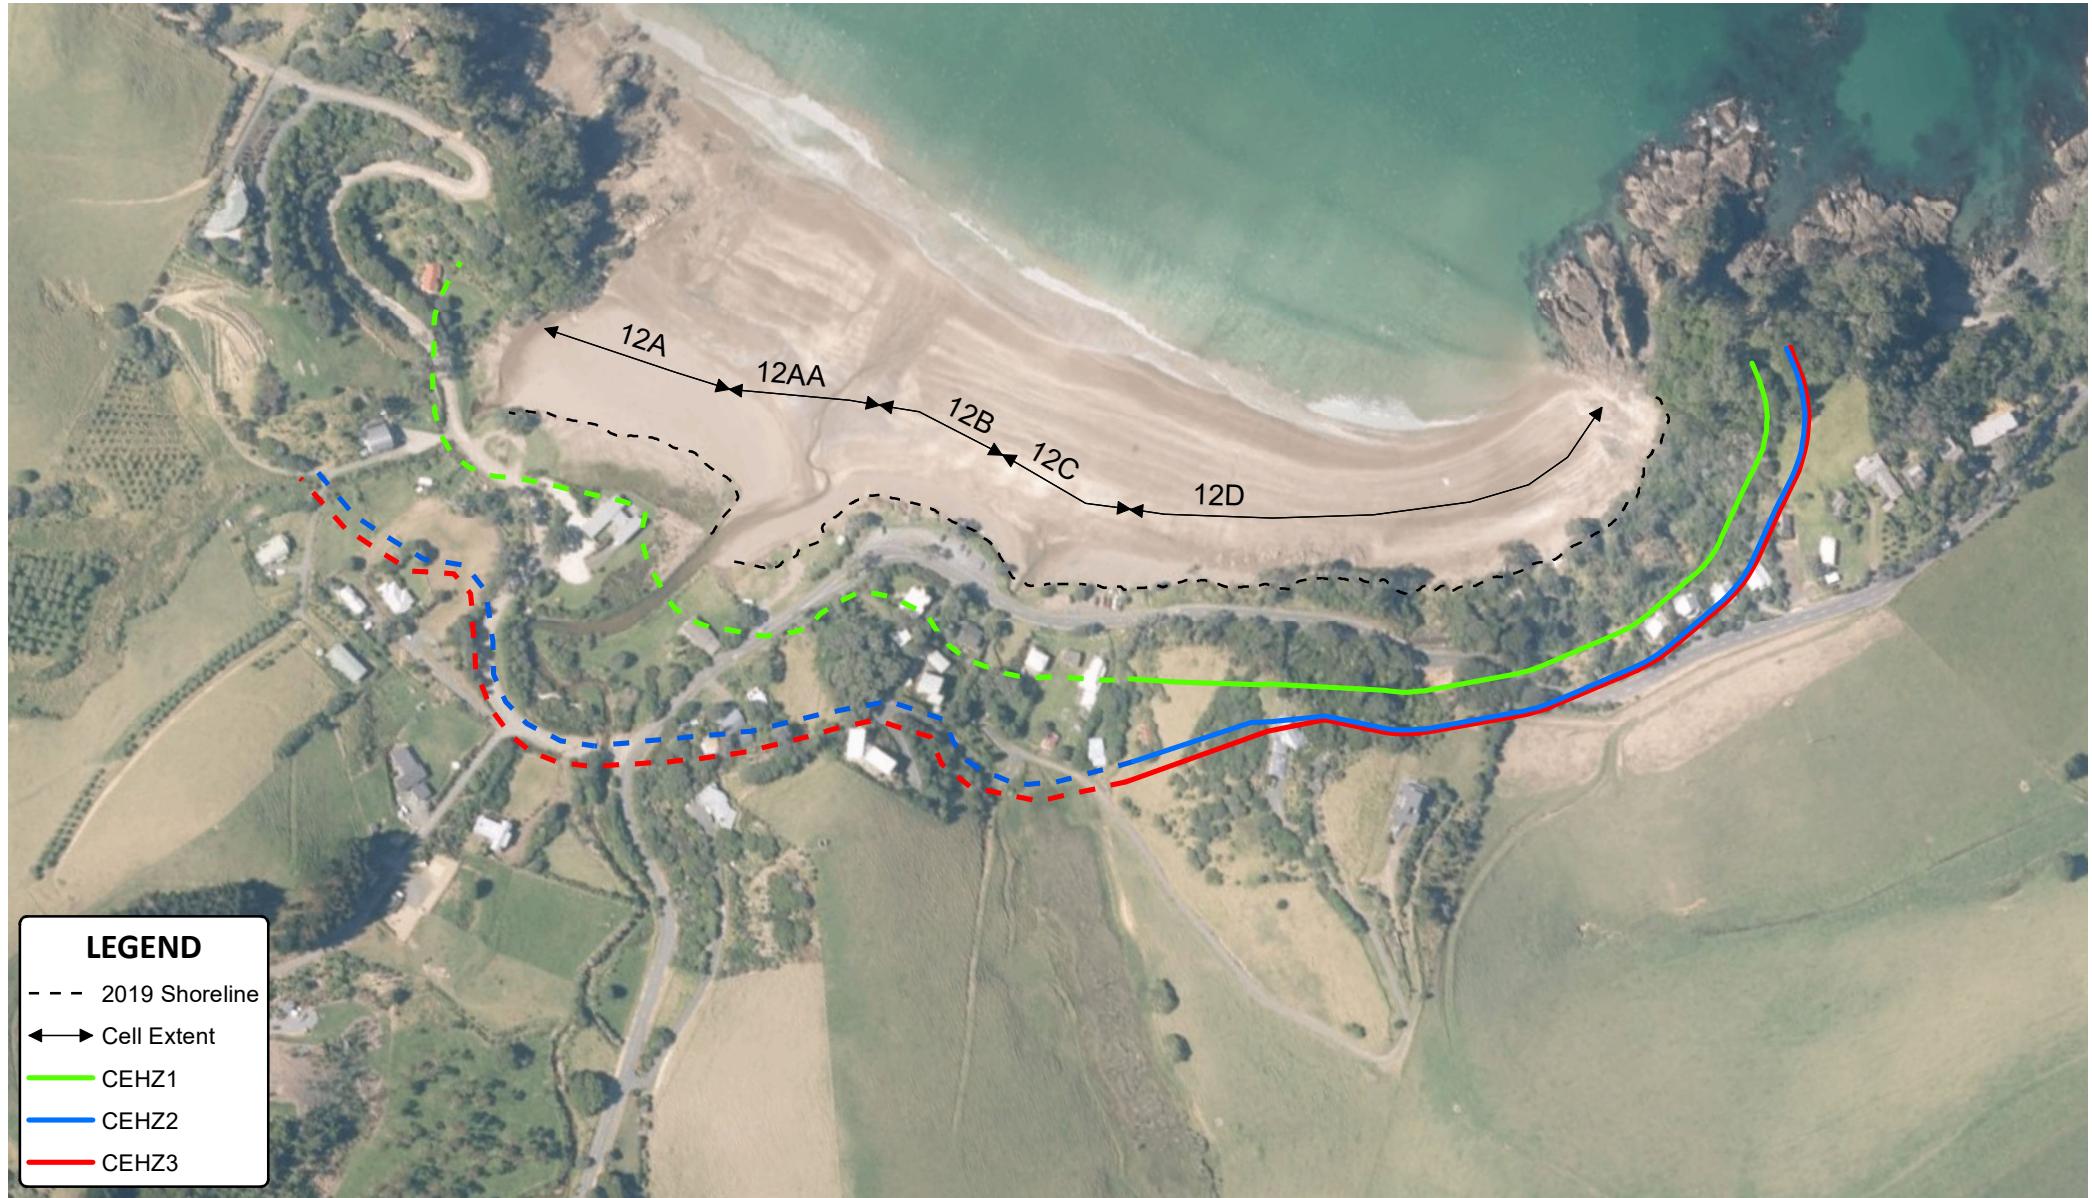
Figure 12-6

Notes: Dashed CEHZ indicates greater uncertainty around stream mouths and backshore topography.
Northland 0.4m Rural Aerial Photos (2014-2016).

Coastal Erosion Hazard Zone widths are presented within Table 12- 2 to 12-4 and Figure 12-6. CEHZ1 values range from 36 to 52 m, CEHZ2 values from 72 to 117 m and CEHZ3

values from 74 to 142 m. These larger values are attributed to the erosional trends of the southern beach and cliff and the relatively flat offshore slopes which result in large sea level rise response.

CEHZs have been mapped in agreement with the calculated values. Except around the streams where fluvial effects increase uncertainty and where the backshore morphology transitions from sand dunes to hill slope. In both these cases lines are dashed to reflect the uncertainty and should be considered on a site-specific basis.

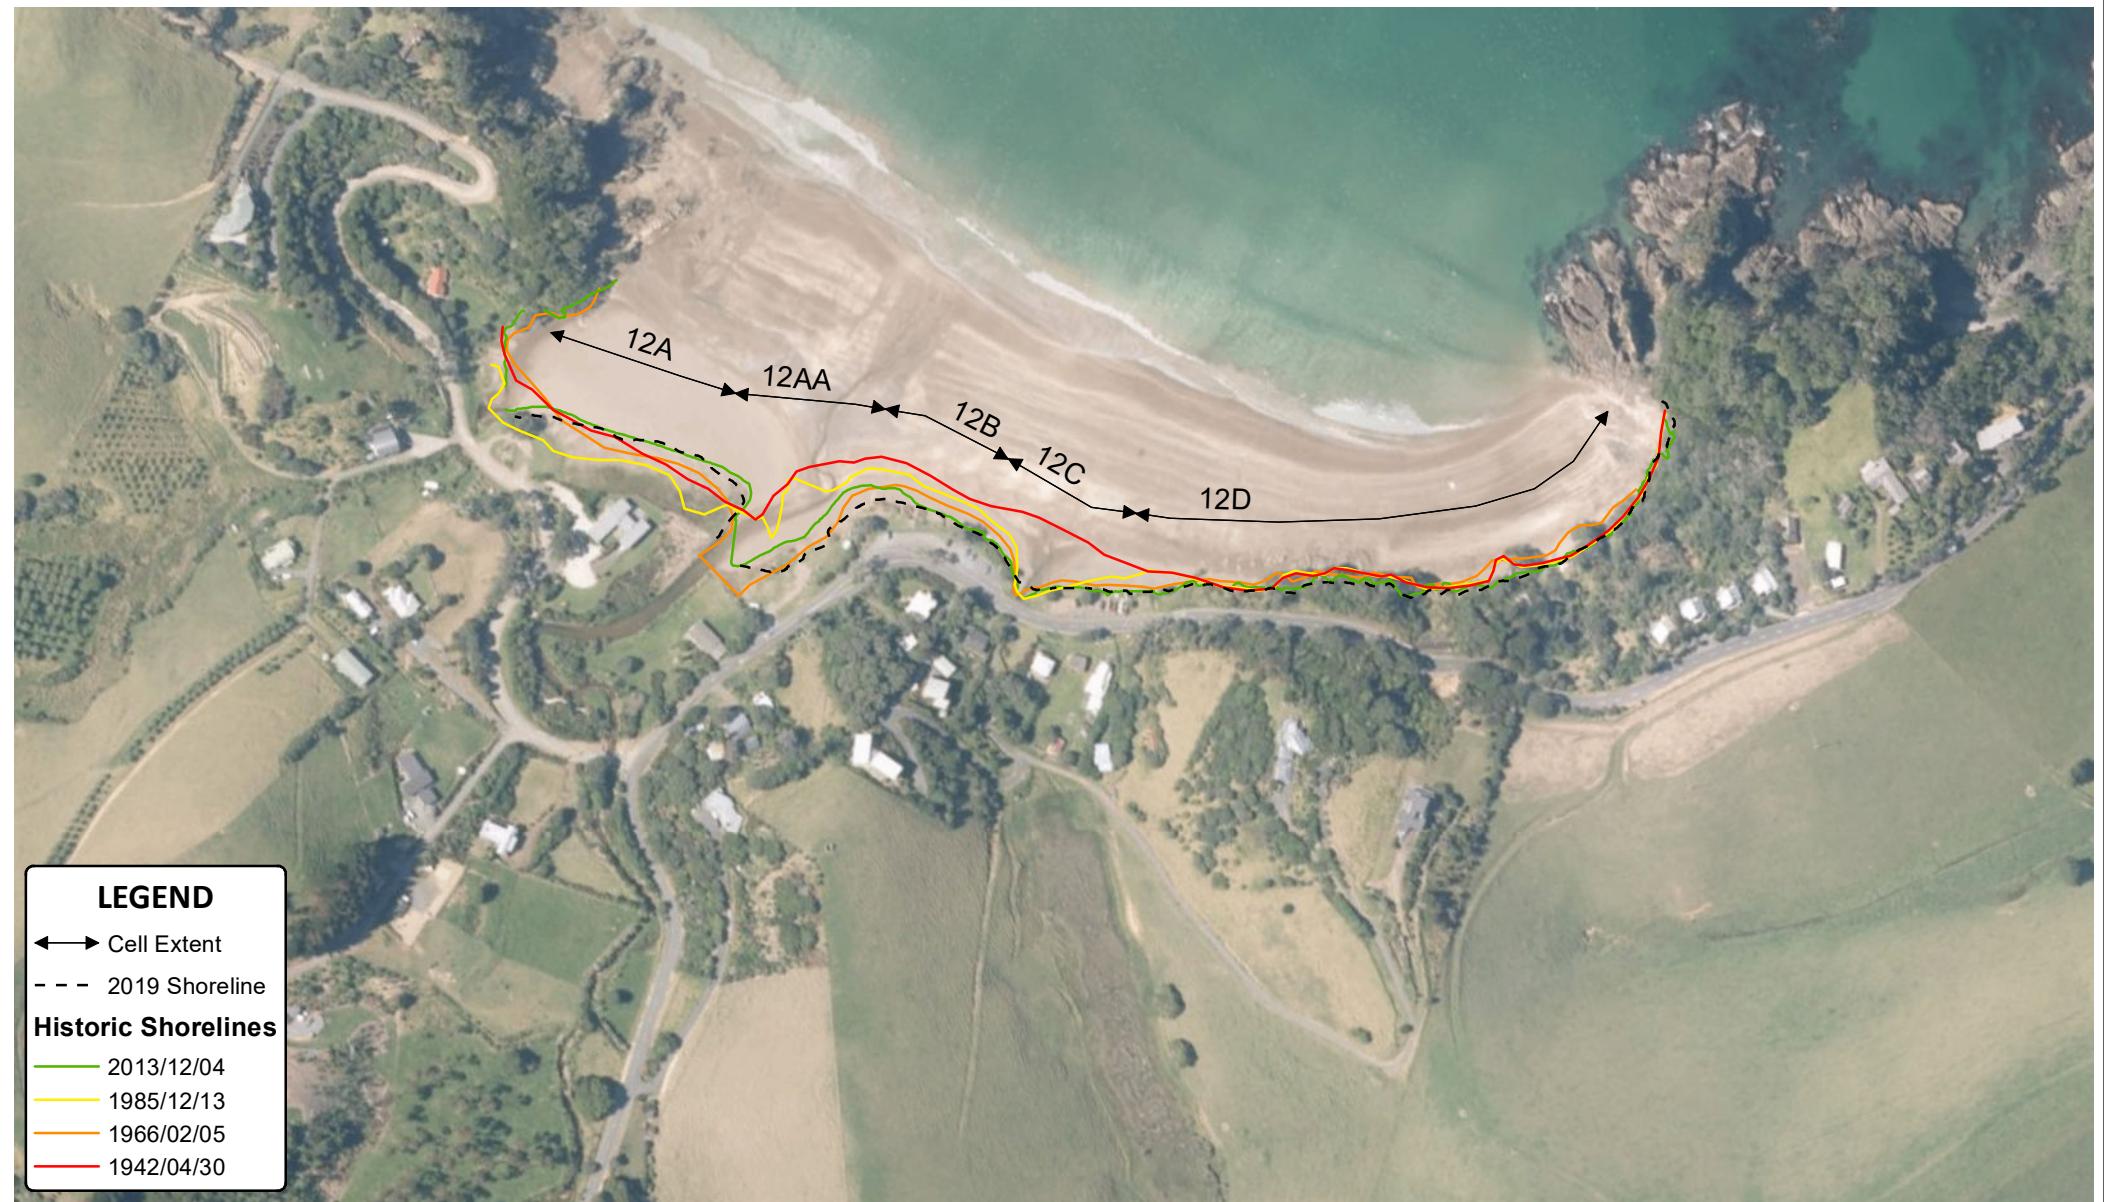
FIGURE No.
Figure 12-7

NORTHLAND REGIONAL COUNCIL
Historic Shorelines
Sandy Bay
Site: 12

Figure 12-7 shows the available historic shorelines for Sandy Bay.
