24 Hihi

Coastal Erosion Hazard Assessment

NORTHLAND REGIONAL COUNCIL
Coastal Erosion Hazard Assessment
Hihi
Site: 24

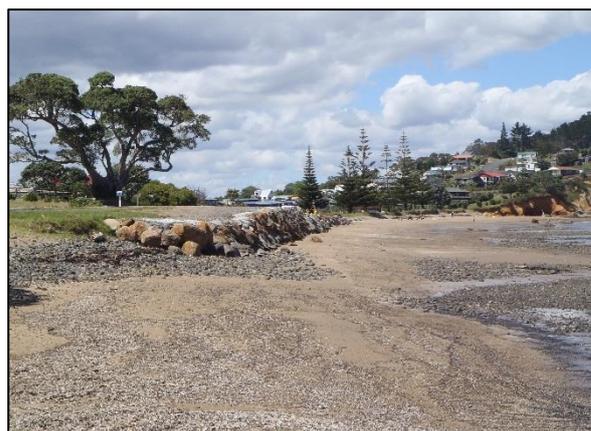
Site Photograph A (north – grouted rock seawall)

The next 400 m of shoreline comprises unconsolidated beach (cell 24C to 24E), of which approximately 150 m is currently fronted by a vertical grouted rock seawall. Another stream mouth is located within the unconsolidated beach which has a localised effect on shoreline position. A boat ramp is located on the northern side of this stream. A low crested seawall comprising cemented sand exists along the beach shoreline south of the stream mouth. The beach comprises fine sand and has a minimal berm above the high tide line. The dune crest in this area is approximately RL 2 to 4 m.

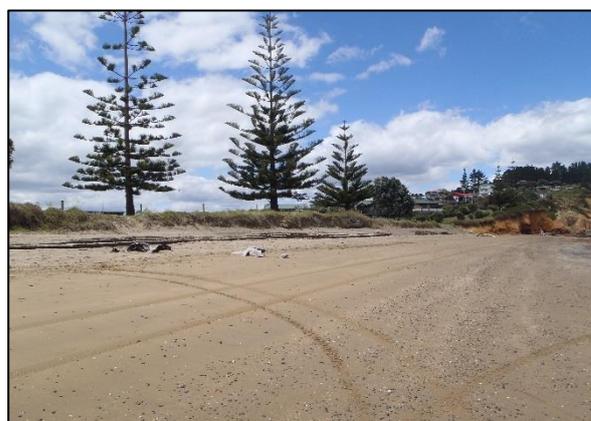
Site Photograph B (central beach dune area)

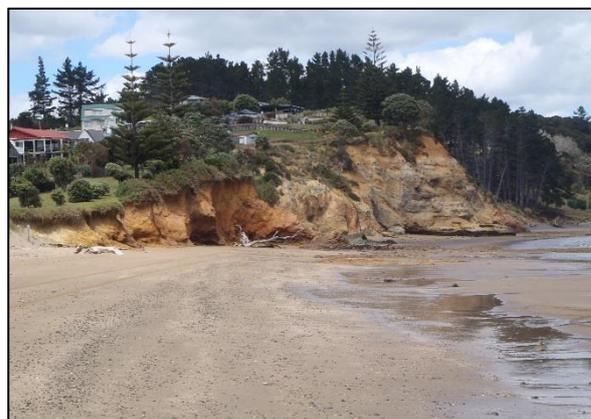
Site Photograph C (south – cliff shoreline)

The remainder of the shoreline is characterised by a cliff shoreline comprising weak sedimentary Mudstone Conglomerate (Mangonui Formation). The cliff height rises up to RL 23 m at the southern extent of the site.

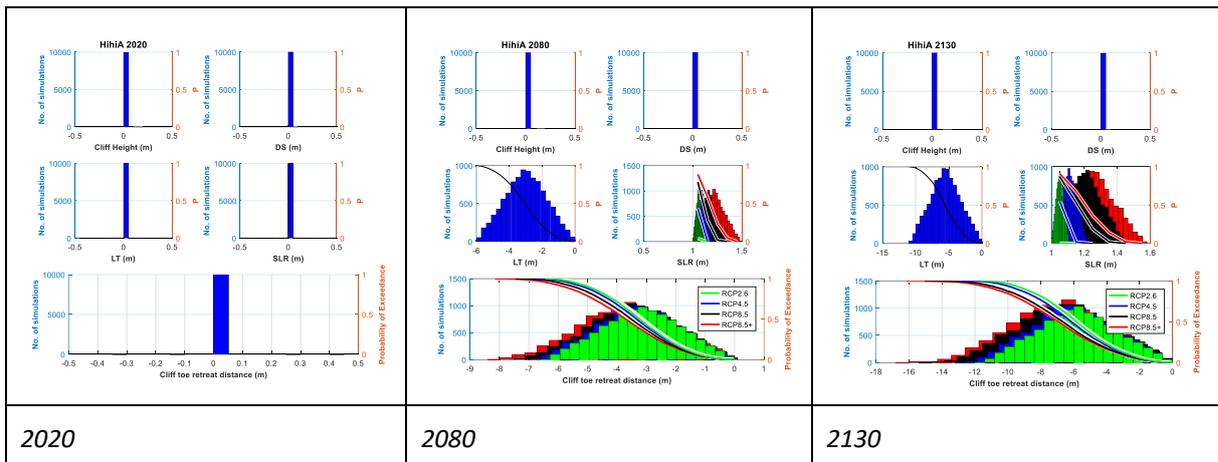
Figure 24-1 Histograms of parameter samples and the resultant shoreline distances for 2020, 2080 and 2130 timeframes for cell 24A

For cell 24A, 24B and 24F the cliff projection method has been adopted with future shoreline distances shown in Figure 24-1, Figure 24-2, Figure 24-6 and Table 24-2 to 24-4 instead of CEHZ distances. The future cliff toe distances range from 3 to 19 m to 2080 and 10 to 80 m to 2130.

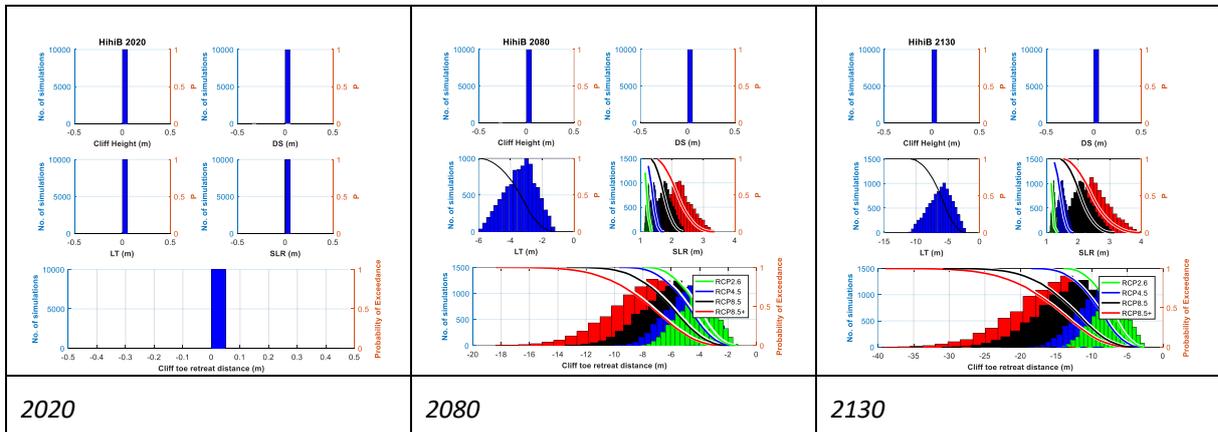
Figure 24-2 Histograms of parameter samples and the resultant shoreline distances for 2020, 2080 and 2130 timeframes for cell 24B

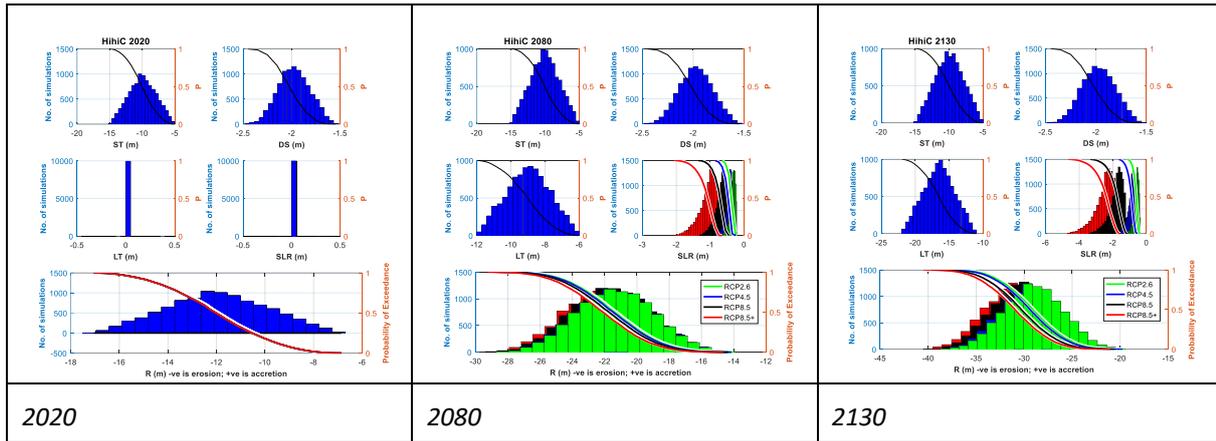
Figure 24-3 Histograms of parameter samples and the resultant shoreline distances for 2020, 2080 and 2130 timeframes for cell 24C

Histograms of individual components and resultant CEHZ distances using a Monte Carlo technique are shown in Figure 24-3 to Figure 24-5. Coastal Erosion Hazard Zone widths are presented within Table 24-2 to 24-4 and Figure 24-7.

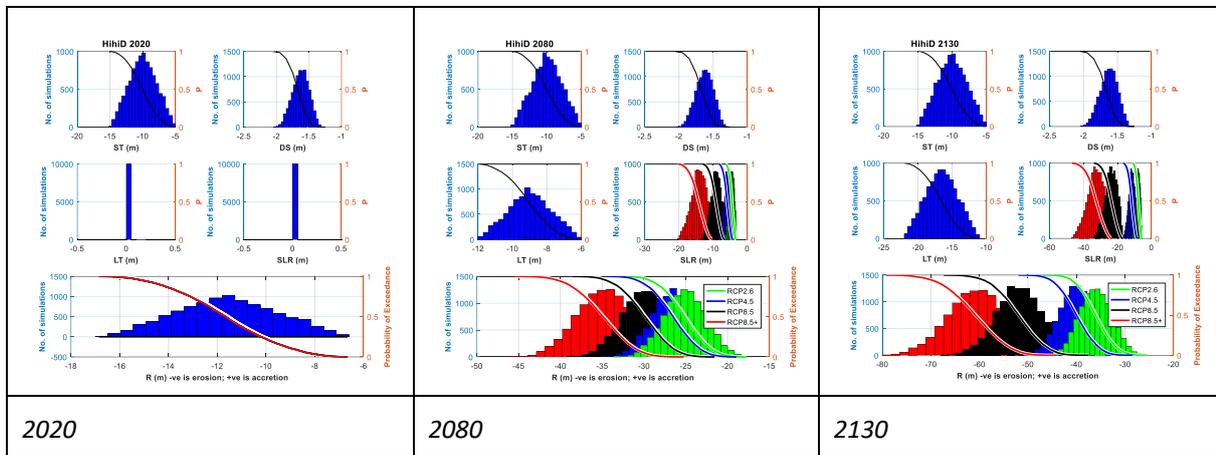
Figure 24-4 Histograms of parameter samples and the resultant shoreline distances for 2020, 2080 and 2130 timeframes for cell 24D

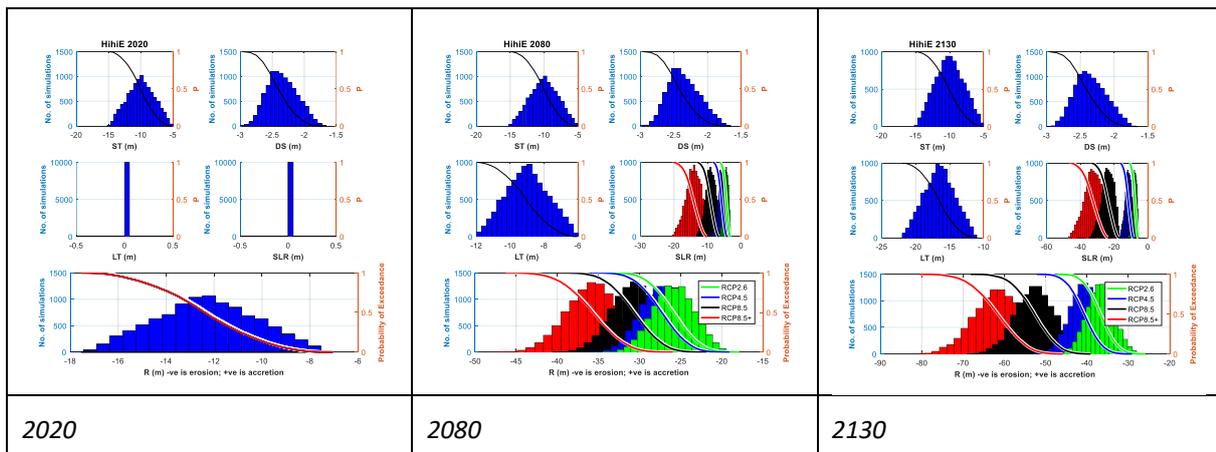
Figure 24-5 Histograms of parameter samples and the resultant shoreline distances for 2020, 2080 and 2130 timeframes for cell 24E

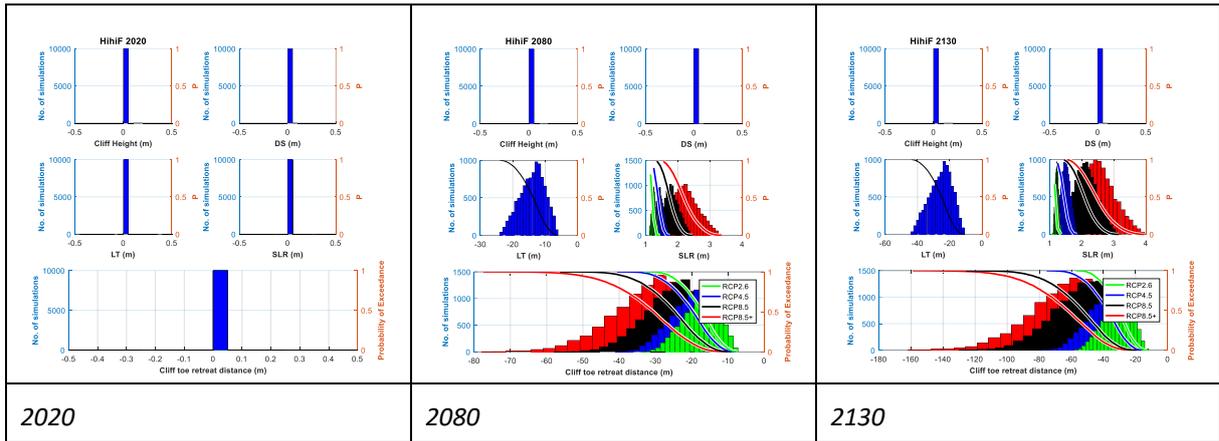
Figure 24-6 Histograms of parameter samples and the resultant shoreline distances for 2020, 2080 and 2130 timeframes for cell 24F

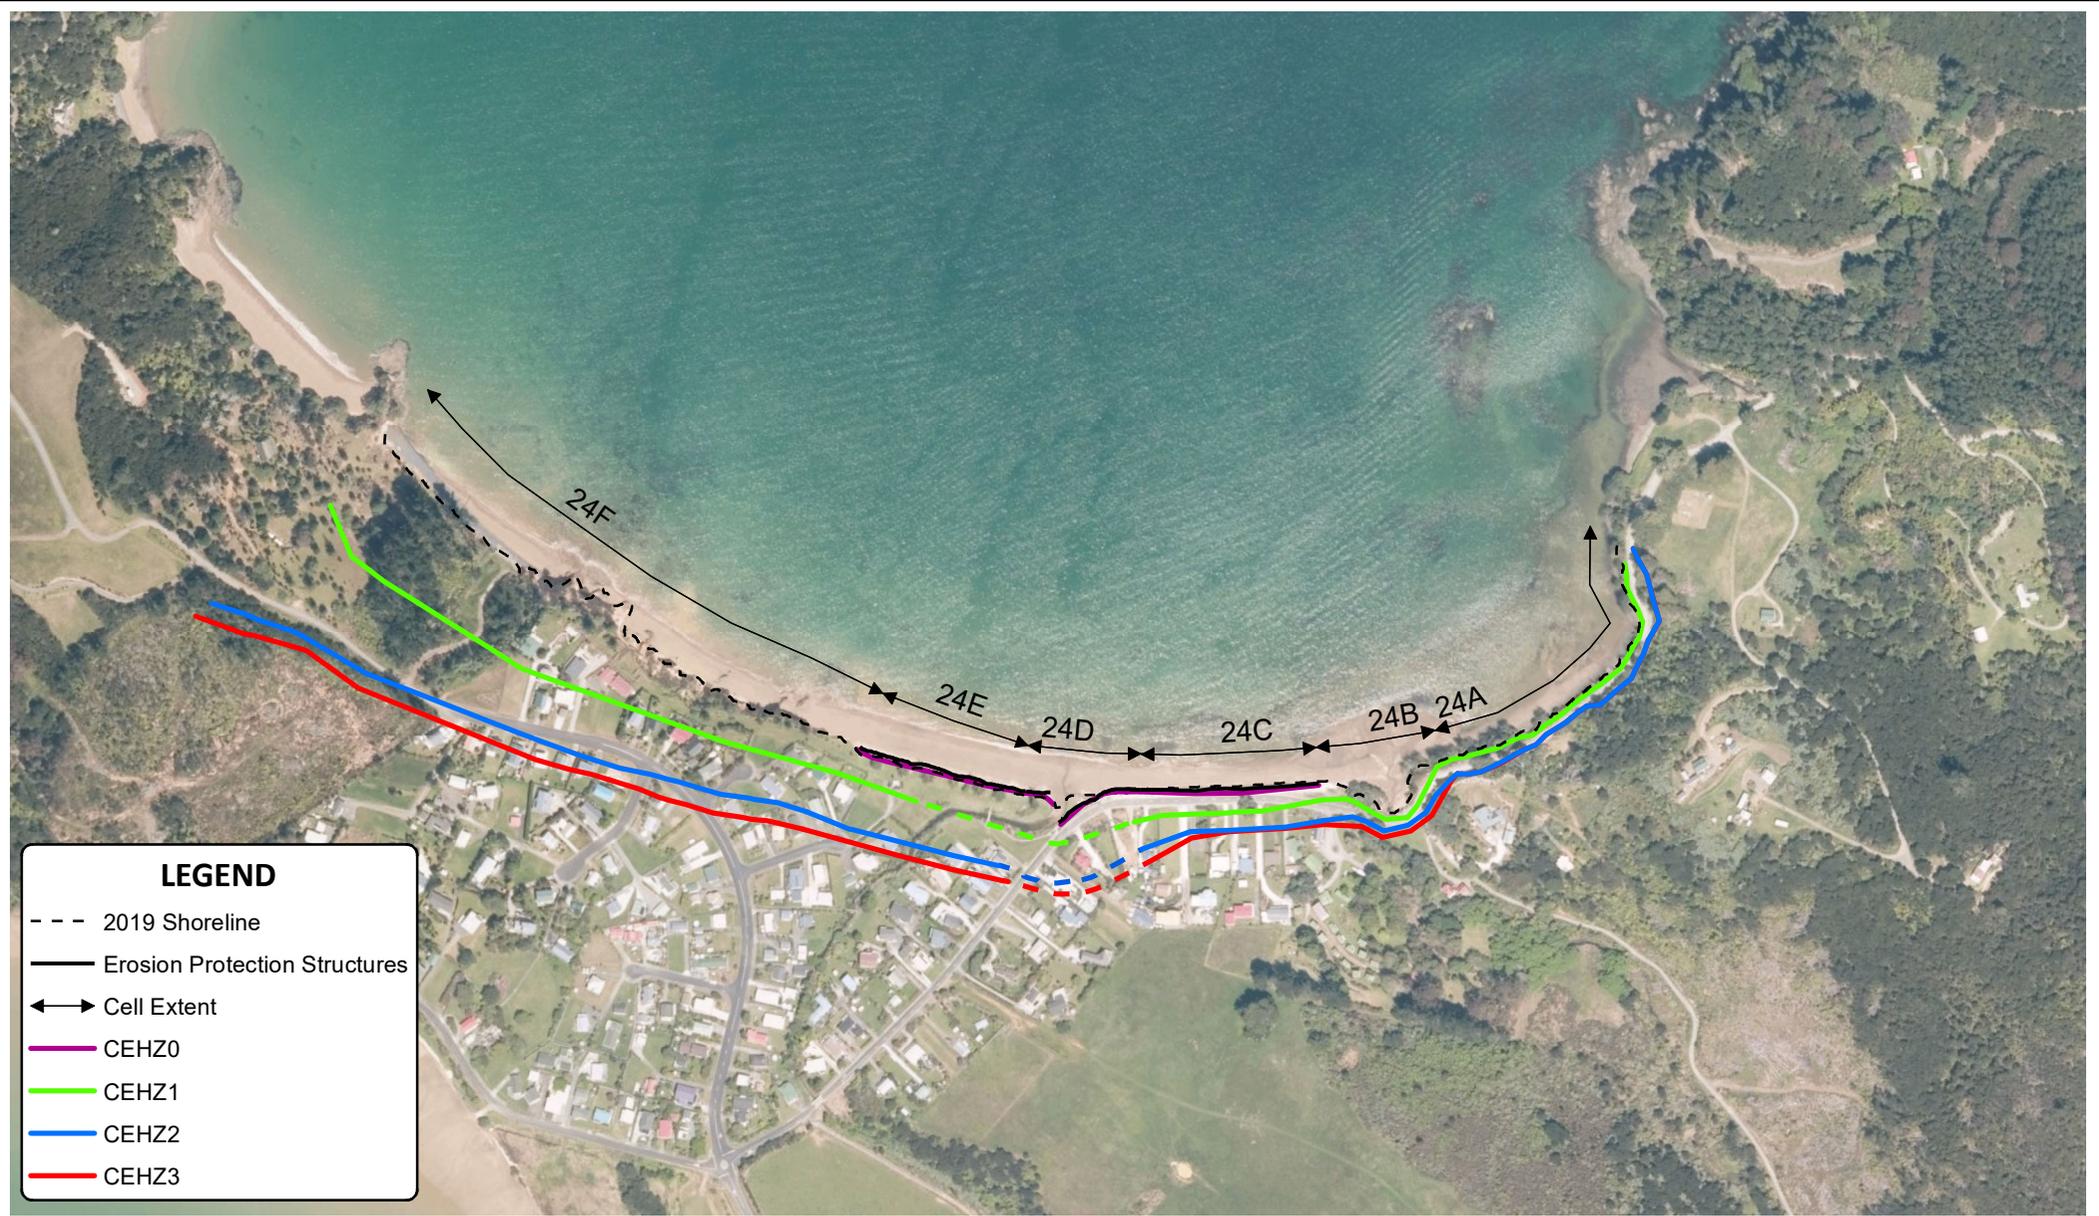
FIGURE No. **Figure 24-7**

Notes: Dashed CEHZ indicates greater uncertainty around stream mouths and backshore topography. Northland 0.4m Rural Aerial Photos (2014-2016).

CEHZ1 values range from 21 to 29 m. CEHZ2 values range from 35 to 60 m. CEHZ3 values

range from 36 to 71 m. CEHZ's have been mapped in agreement with the calculated values. Note that at cell 24D an area with a length of 25 m have likely been reclaimed, with CEHZ offset from the most recent shoreline.

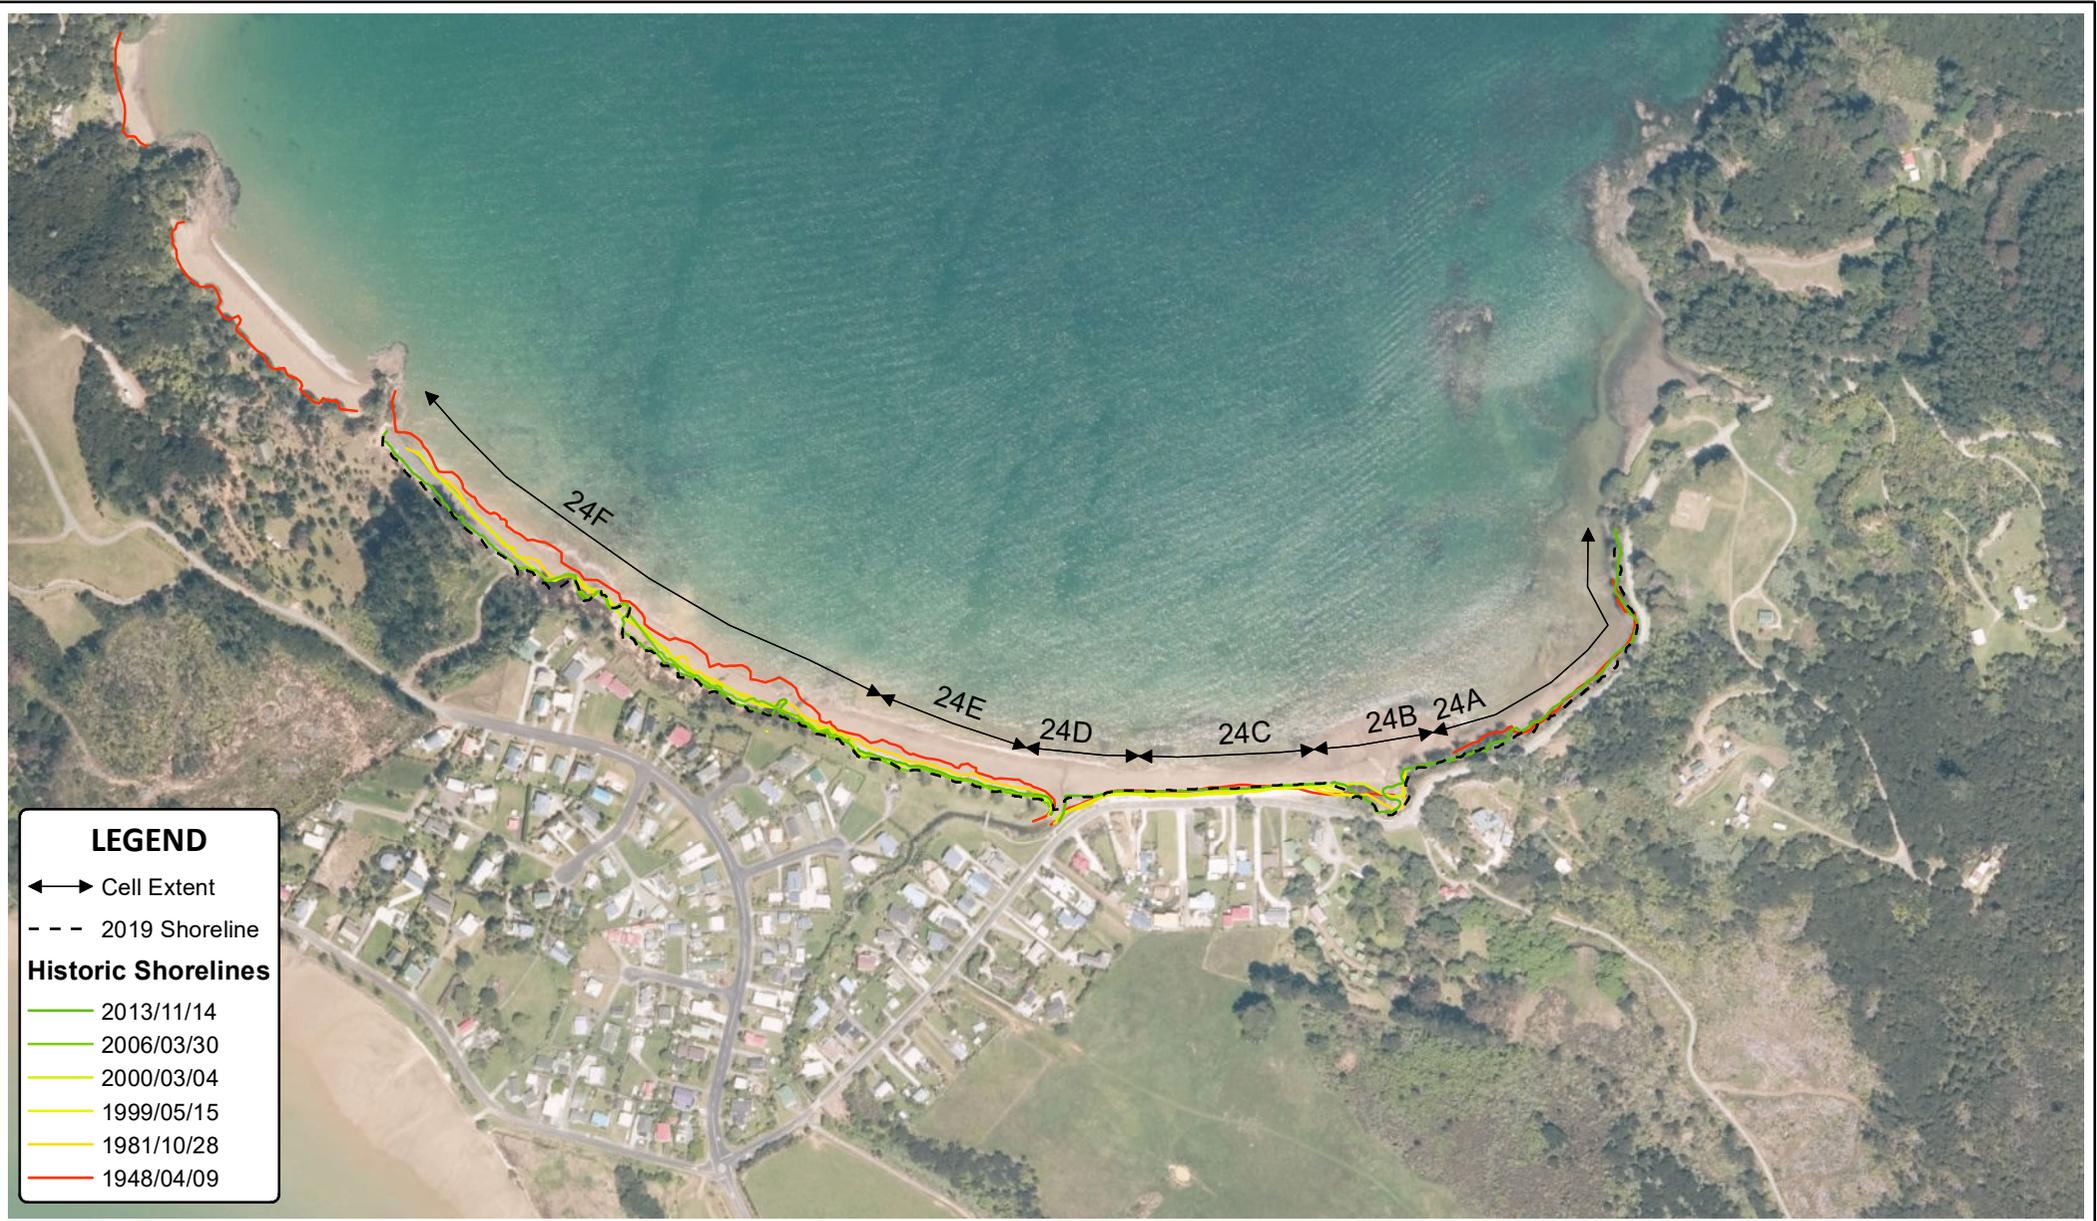
FIGURE No.	Figure 24-8	Rev.	1
------------	-------------	------	---

NORTHLAND REGIONAL COUNCIL
Historic Shorelines
Hihi
Site: 24

Figure 24-8 shows the available historic shorelines for Hihi.
