41 Glinks Gully

NORTHLAND REGIONAL COUNCIL

Coastal Erosion Hazard Assessment

Glinks Gully

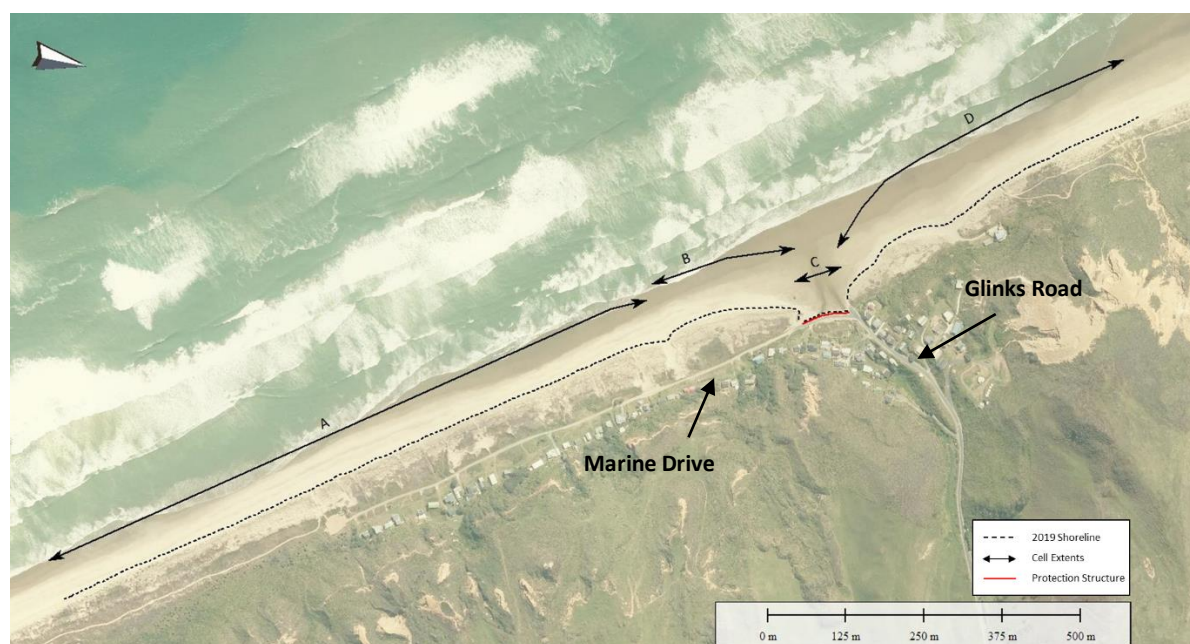
Figure 41.1: Map showing 2019 shoreline position and cell extents with background aerial imagery from 2014.

Glinks Gully is located on the west coast of Northland 15 km southwest from Dargaville. Figure 41.1 shows the site and its division into four coastal cells for the purpose of assessing coastal erosion hazards. Site photos showing key features of the coast are presented in Figure 41.2.

The site is split into four cells based on discrete spatial differences in coastal geomorphology and historic shoreline changes. Cells A, B and D are characterised by prograding sand dunes and Cell C is influenced by beach access and a reclaimed road. Component values used to calculate coastal erosion hazard zones are presented in

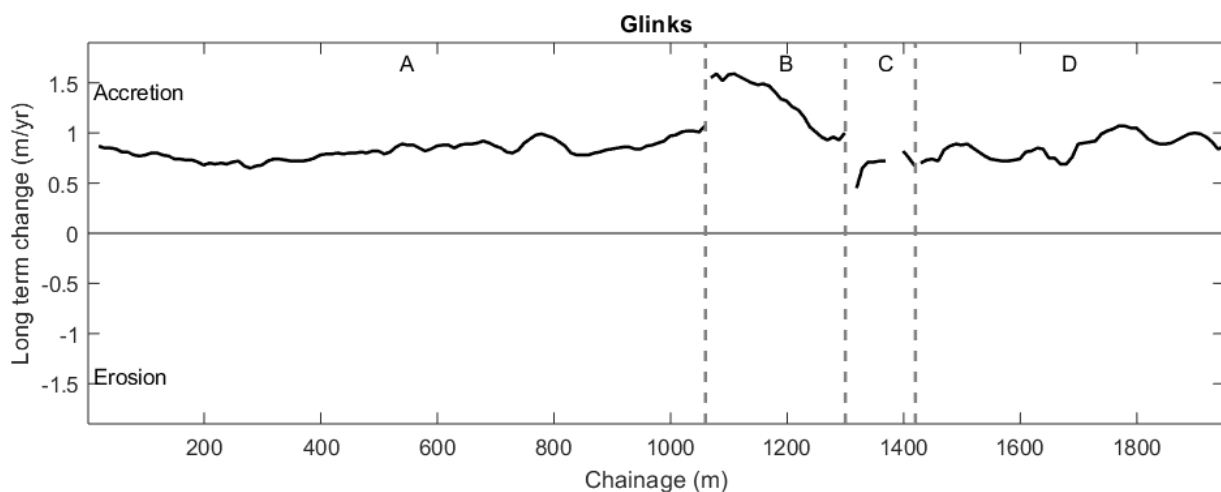
Figure 41.3: Rate of long-term shoreline change along the site showing each cell.

Cells A and D are open coast beach systems at the northern and southern extents of the site and have similar rates of historic long-term change that average +0.5 m/yr of accretion. Cell B is a discrete section of dune between a blowout and the beach access and has a higher rate of accretion averaging +0.8 m/yr. The minimum long-term rate adopted for each cell was lower than indicated by shoreline change analysis to account for possible future changes in sediment supply or that the dune toe accretion may reach a seaward equilibrium with the hydrodynamic process regime.

Accurate analysis of long-term change at Cell C is complicated by construction of the reclaimed road that now defines the shoreline and a nominal rate of 0 ± 0.1 m/yr was adopted. The shoreline at Cell C is landward of other cells that represent more open-coast dune systems. The intertidal beach at Cell C also lower in elevation because of the valley influence and vehicle access. Therefore, the same short-term erosion distance was adopted for Cell C.

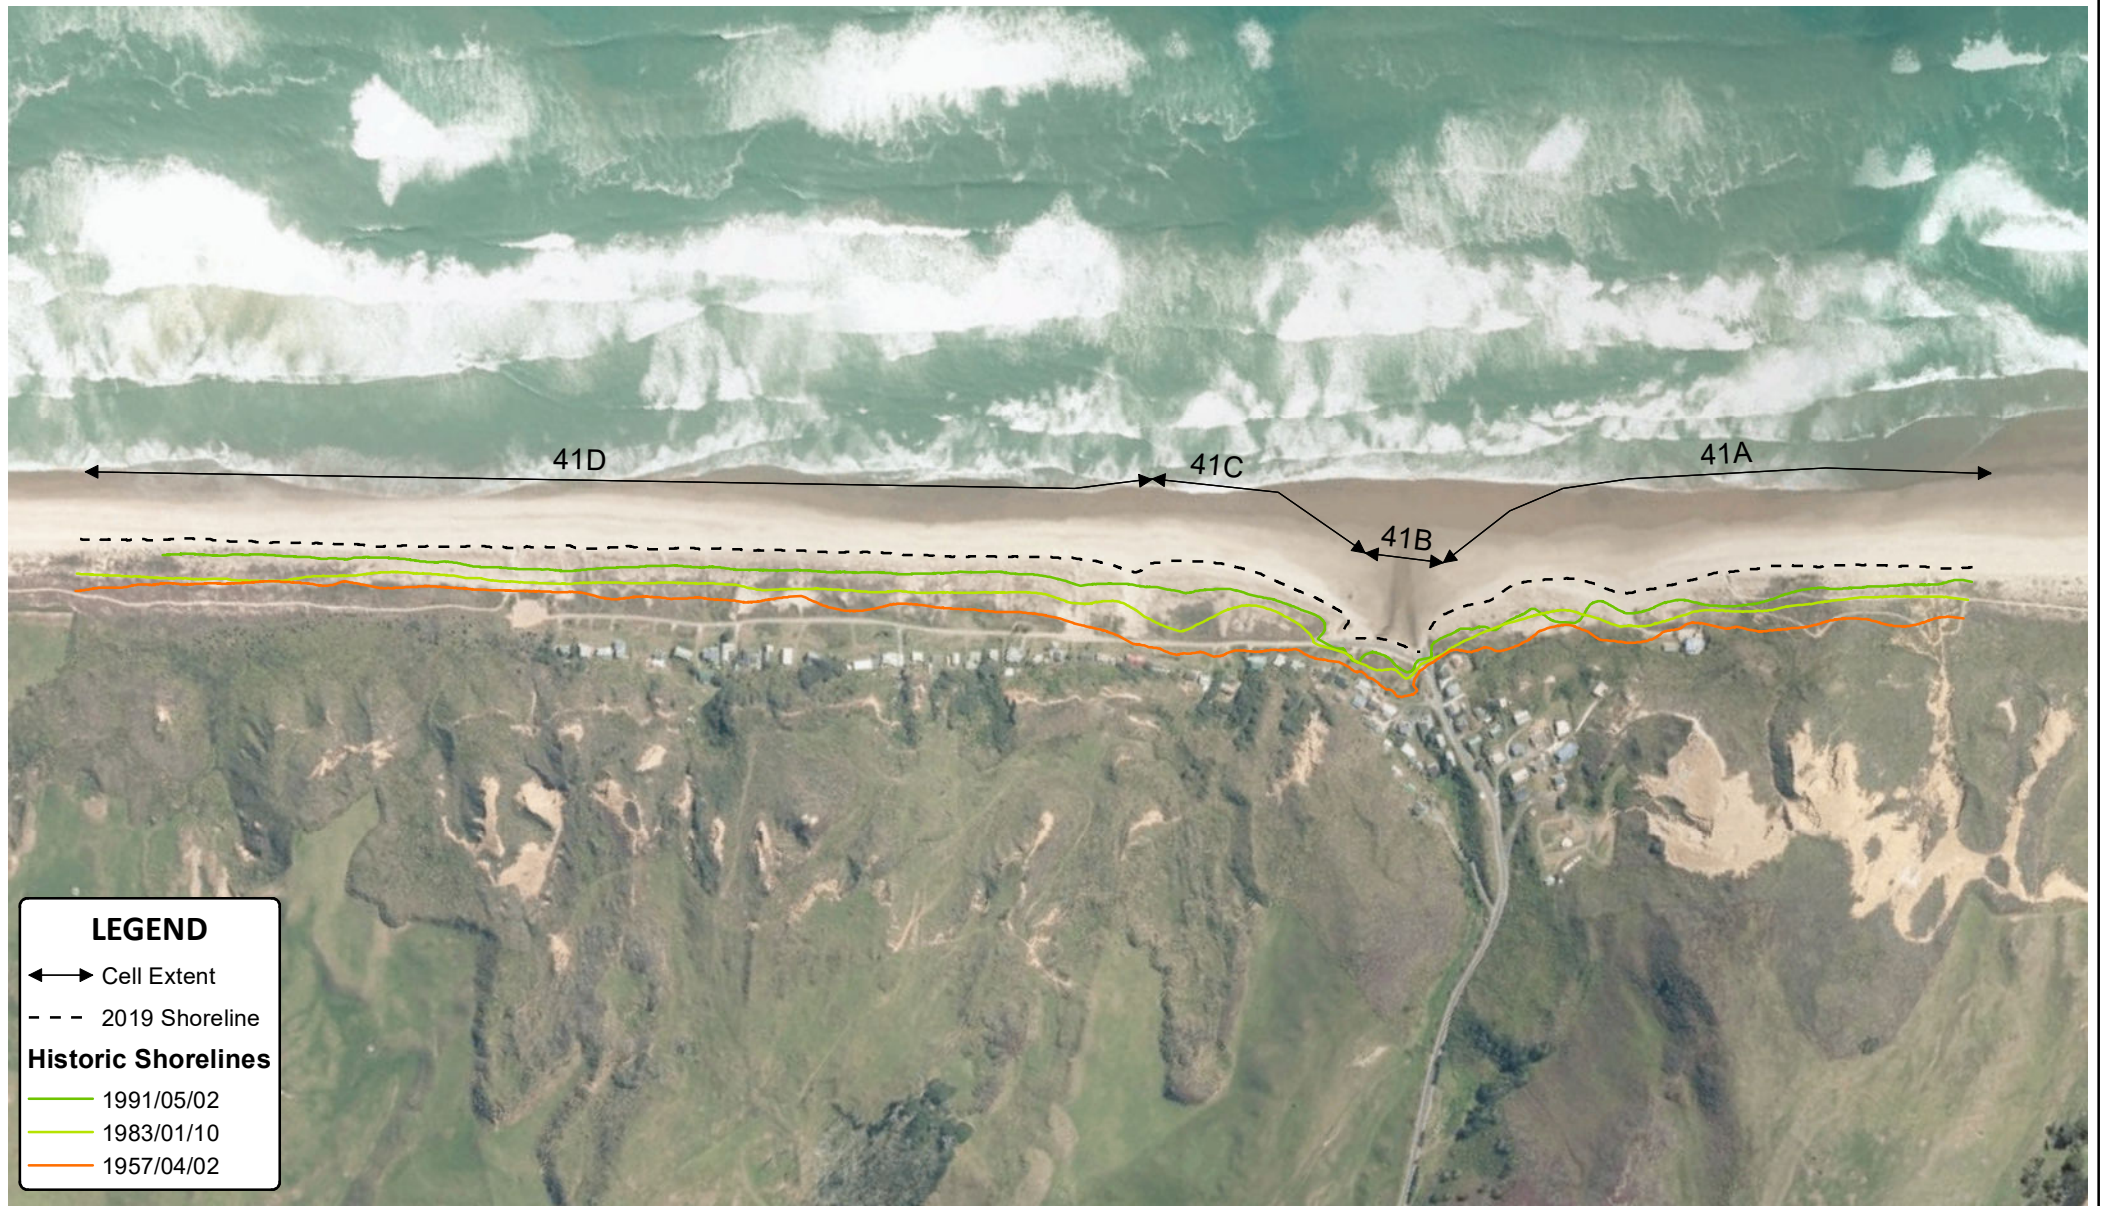
NORTHLAND REGIONAL COUNCIL		
Historic Shorelines		
Glinks Gully		
Site: 41		
FIGURE No.	Figure 41-9	Rev.
		1

Figure 41.9 shows the available historic shorelines for Glinks Gully.
